LAKE WILHELM DAM

NDI No. PA 00900  
PennDER No. 43-53  
SCS No. PA 475

**PHASE I INSPECTION REPORT**  
**NATIONAL DAM INSPECTION PROGRAM**

July 1979

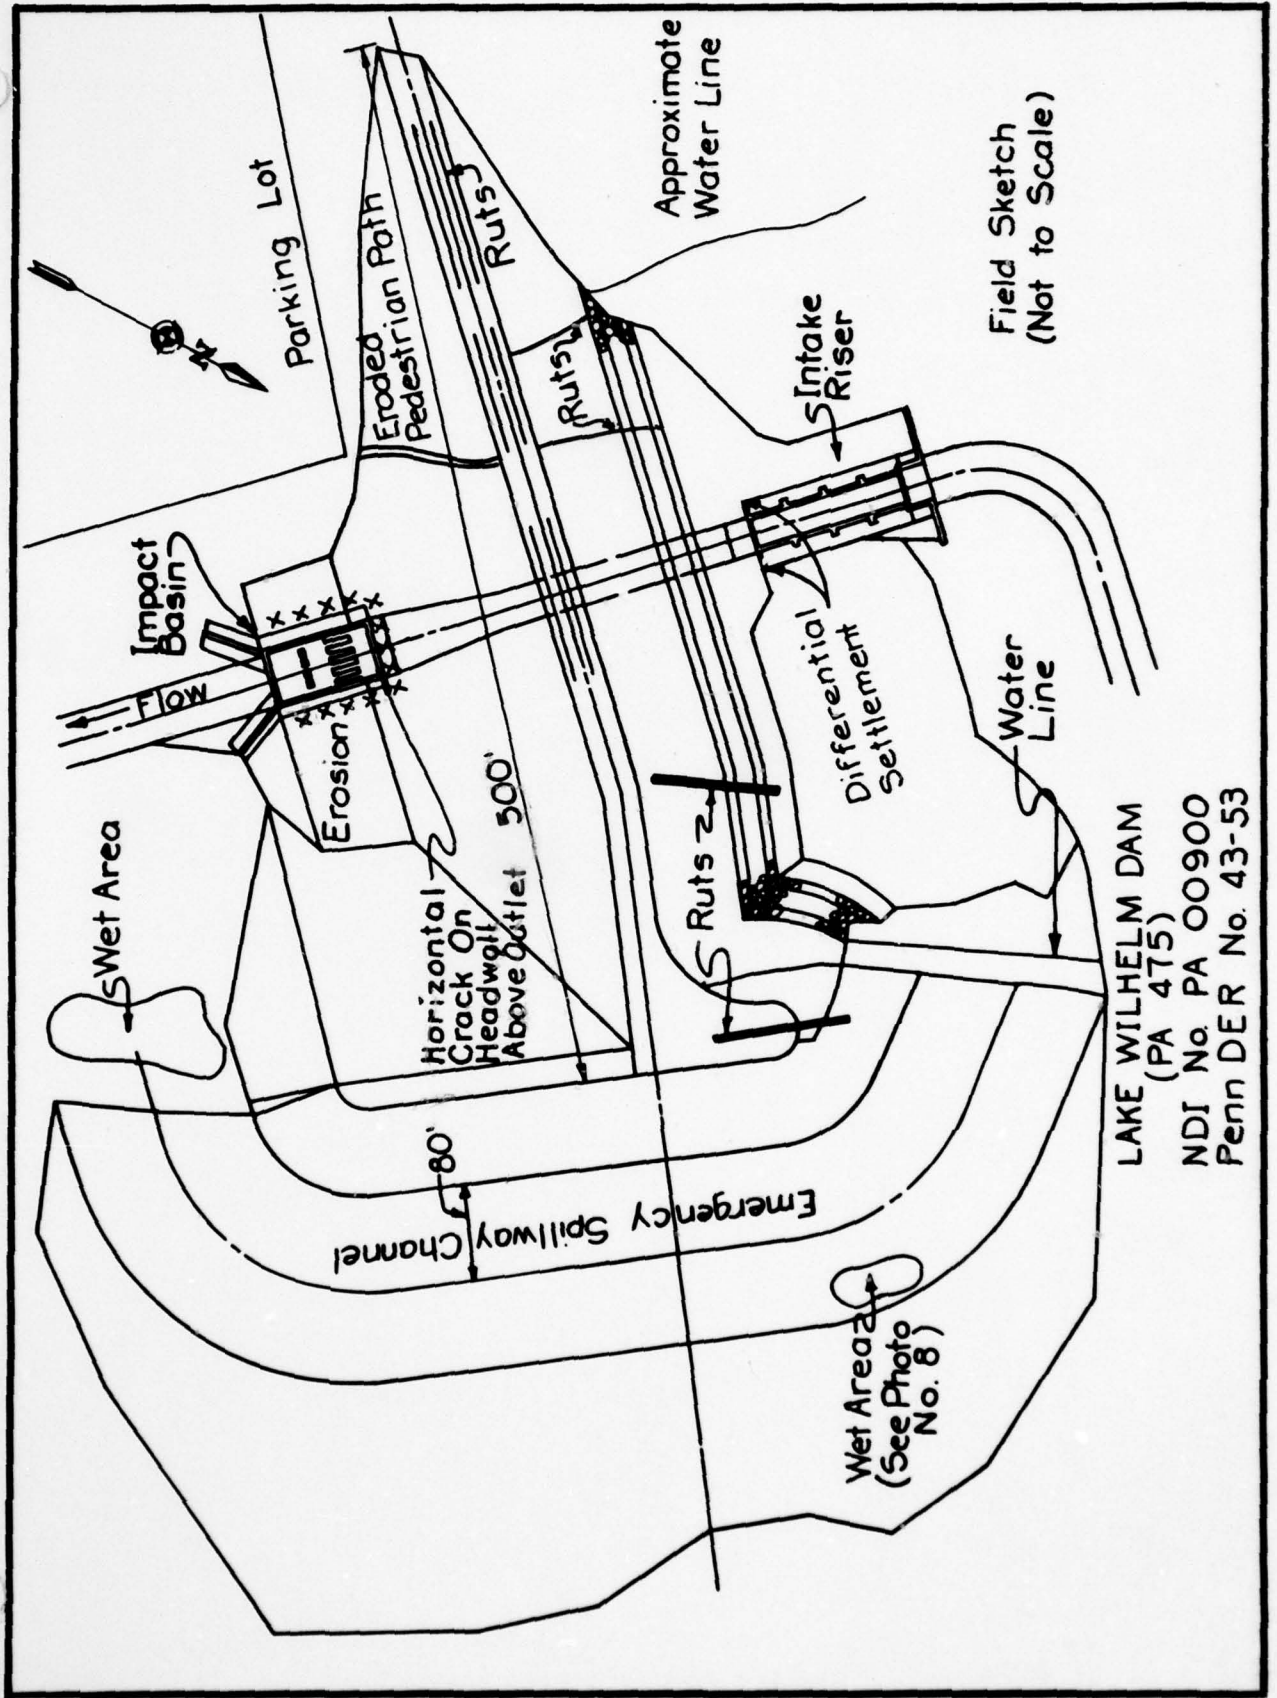
Field Sketch  
(Not to Scale)

- b. Dam - A bare, eroded pedestrian path is present on the downstream face of the dam leading from the parking lot and sanitary station to the crest of the dam. Several smaller ruts and erosion paths were noted on the embankment (see field sketch for locations).

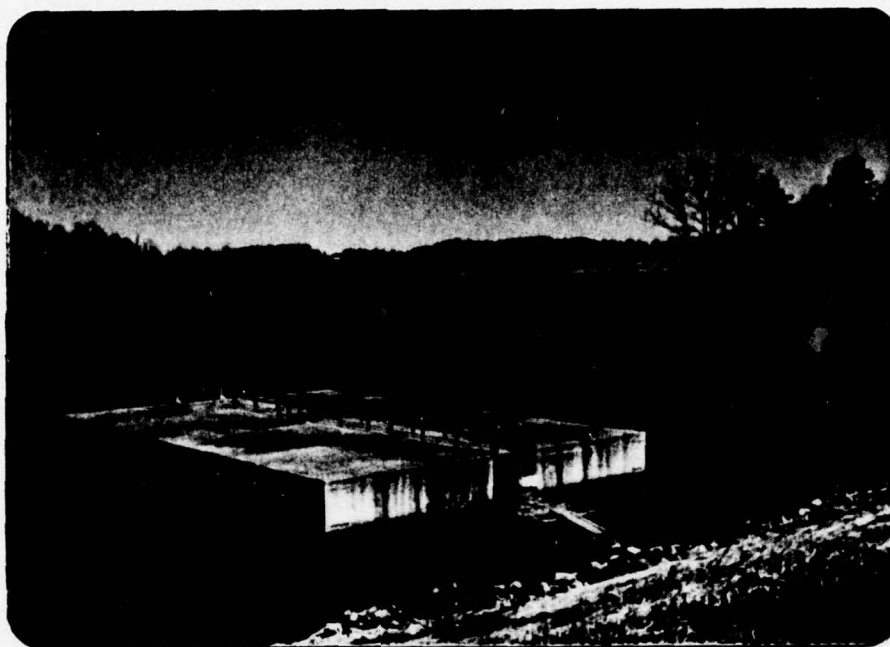
**PHOTO 1. Intake Riser Assembly**  
**(Orange Marks Above Existing Pool Indicate Previous Highest Water Level)**

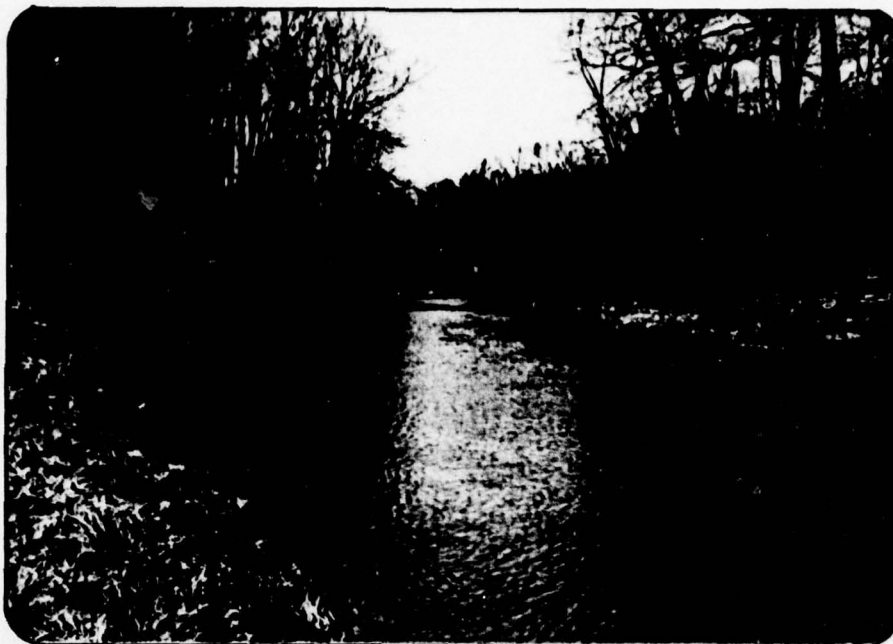
**PHOTO 5. Downstream Channel as seen from Emergency Spillway Exit**

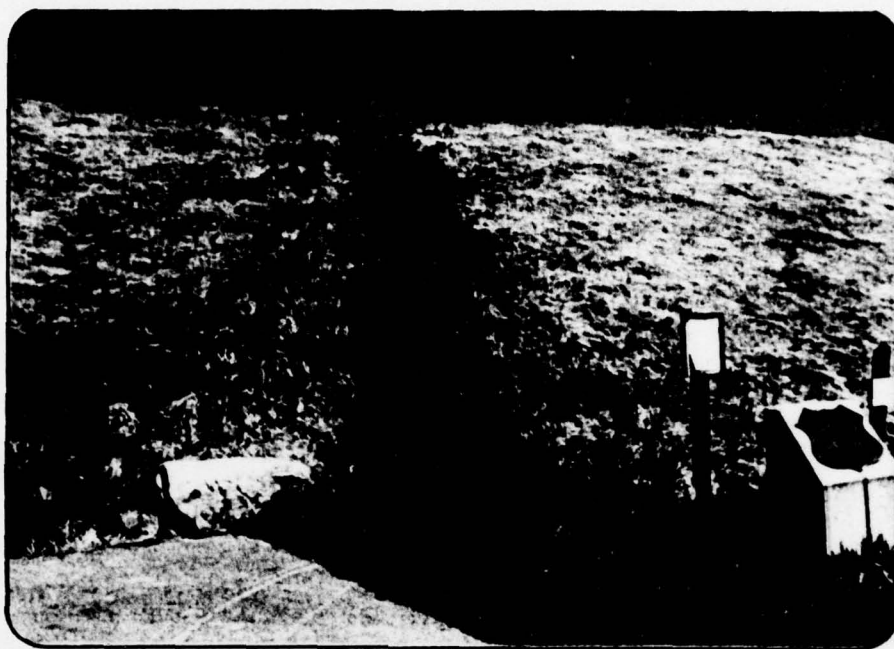
1. A bare, eroded pedestrian path is present on the downstream face leading from the parking lot and sanitary station to the crest of the dam.
1. Recommend installation of permanent walkway to prevent further reoccurrence.
2. Several ruts and small erosion paths were noted on the crest and upstream face.
2. The ruts and erosion paths should be regraded, treated and seeded with an appropriate mixture to prevent erosion.
3. Erosion was observed around the stilling basin.
3. Recommend that the area be regraded, treated and seeded to prevent erosion. If the problem reoccurs, then riprap should be placed.

**PHOTO 7. Eroded Pedestrian Path on Downstream Face Leading from Parking Lot to Crest of Dam (Green grass on both sides of path indicates that attempts were made to control erosion. Recommend permanent steps be installed in this area.)**

- 1) The eroded areas should be graded, treated and seeded with an appropriate seeding mixture to prevent erosion.
- 2) A permanent walkway should be installed or necessary repairs made on the downstream face leading from the parking lot to the crest of the dam. A permanent walkway would eliminate the damage to the embankment caused by the heavy pedestrian traffic in this area.
- 3) The overgrowth of vegetation should be removed from the riprap.
- 4) The crack in the head wall above the outlet conduits should be repaired.

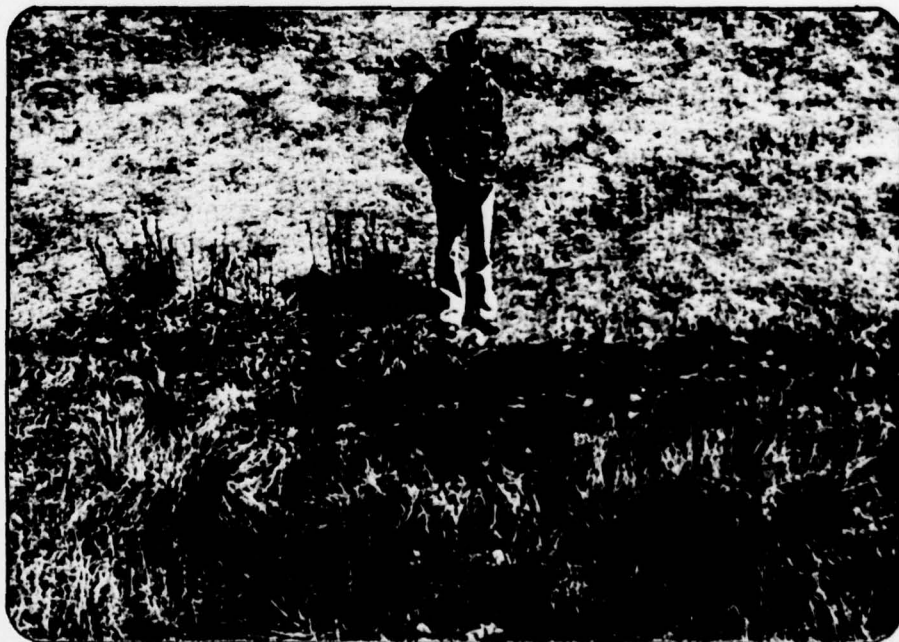
- c. Urgency - The owner should initiate without delay the recommendations discussed in paragraph 7.1.d.
- d. Necessity for Additional Data/Evaluation - The visual inspection indicated the existence of two marshy areas in the emergency spillway channel. The area in the approach channel is believed to be the result of natural springs; however, the cause of the marshy area in the exit channel could not be determined. It is therefore recommended that a monitoring program for the marshy areas be established to determine if quantity or quality changes take place and to institute appropriate action, if necessary.

**PHOTO 8. Marshy Area Located in Entrance Channel at Emergency Spillway**

- 1) The owner should initiate a monitoring program for the marshy areas to determine if quantity or quality changes take place and to institute appropriate action, if necessary. If the cause of both areas is the result of natural springs, the installation of spring drains is recommended.
- 2) The owner should initiate a program whereby the movement of the riser could be monitored and appropriate remedial measures taken, if required.
